Vessel Survey Report No. 2055

Vessel surveyed: 'BARBARA ANN' Legnos 35 Hard-chine Lobsterboat/Scalloper

Purpose of survey: Valuation

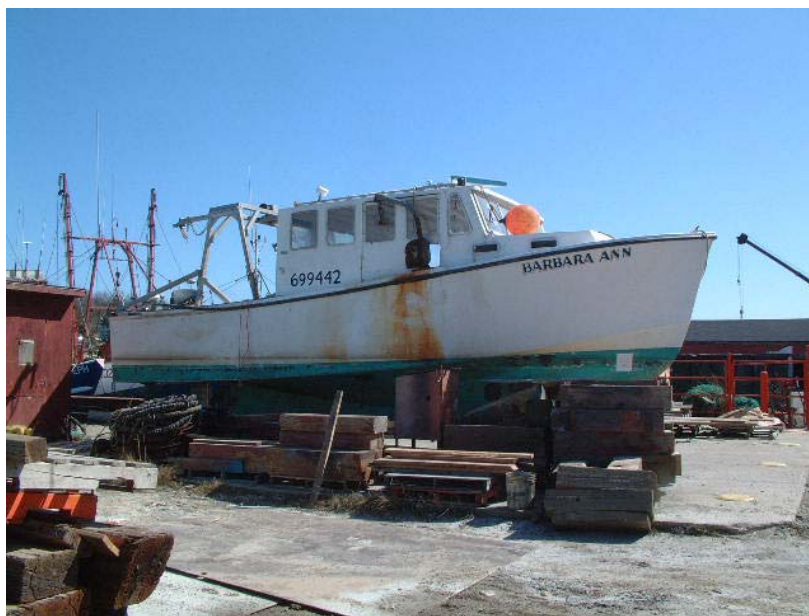
Starboard side outboard profile of 'BARBARA ANN'.

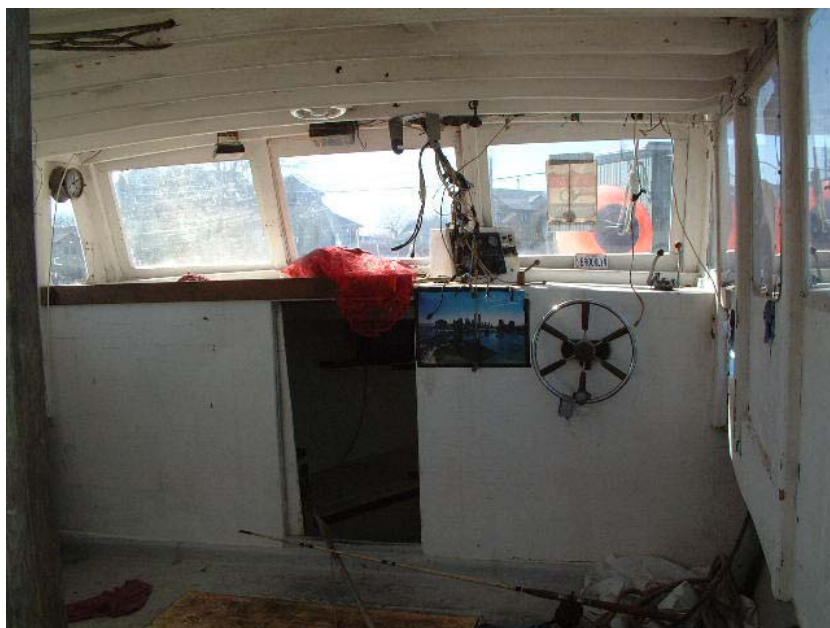
**The fold-up panel to starboard has been damaged and needs repair.**

**The pot hauling arm to starboard has had it's mounting bolts sheared away and needs inspection & repair.**

**The wiring harness in this space needs replacement as there is much salt water verdigris.**

**Wheelhouse, looking forward.**

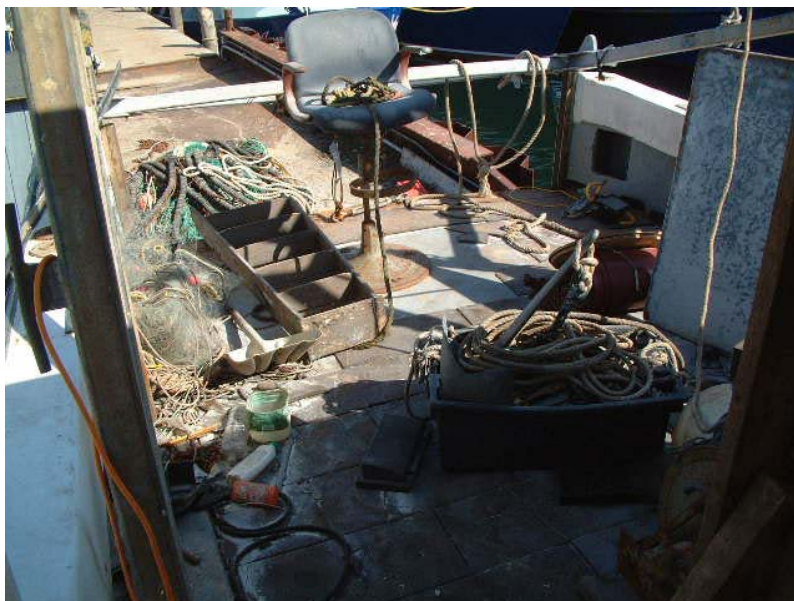
**The deck hatch is fabricated of plywood and needs replacement.**

**The workdeck is cluttered with debris and components.**

**Many of the 12" x 24" asphalt tiles are missing on the centerline aft.**

**Workdeck, looking aft from wheelhouse.**

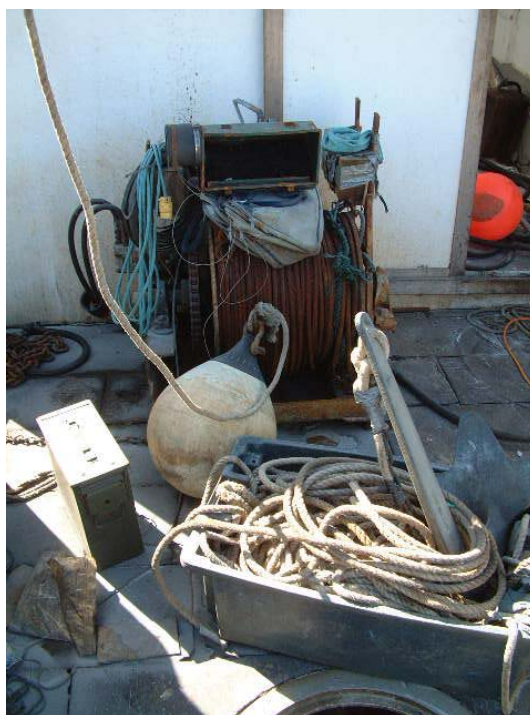
**Hydraulic winch mounted on centerline.**

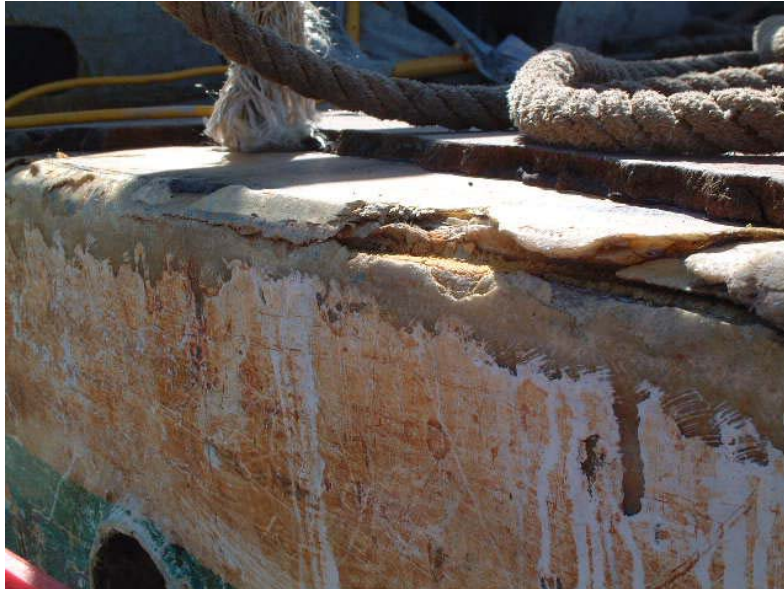
All interior tabbing and structural members are in good condition with no signs of de-lamination or rough service noted. The exterior of the hull was tapped by phenolic hammer and no signs of voids or de-lamination of the hull was found with the exception of the transom face which is totally de-laminated and separated from the workdeck at the transom wall. This is pre-existing damage not a result of the sinking.

**De-laminated transom wall at deck edge.**

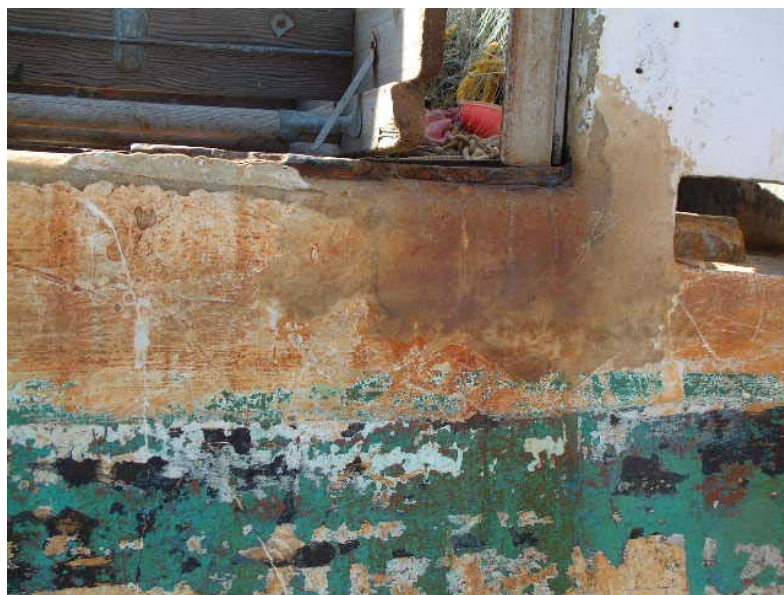
**Crude repairs attempted at corner of transom; these have failed.**

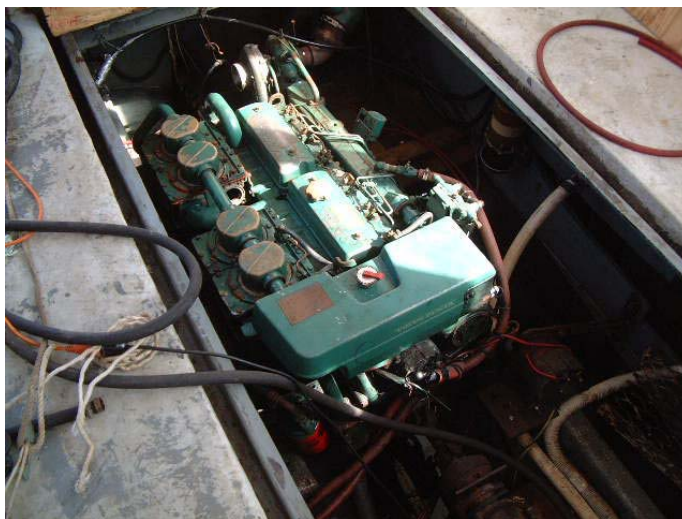
**The main engine and her components needs inspection and possible repairs.**

**The main engine controls are frozen and/or broken, replace.**

**The main engine wiring and gauge panel will require inspection and possible repair/replacement.**

**VOLVO main engine.**

**MORSE controls (from both stations) and an alarmed panel with SW gauges will need replacement.**

**Engineroom is filled with standing oil/water.**
